**National Highway
Traffic Safety
Administration**

Case Vehicle (A): 1998 Lincoln
 Type: Continental, 4-door sedan
 Driver: 66-year-old female
 CDC: 12-FCEN-3

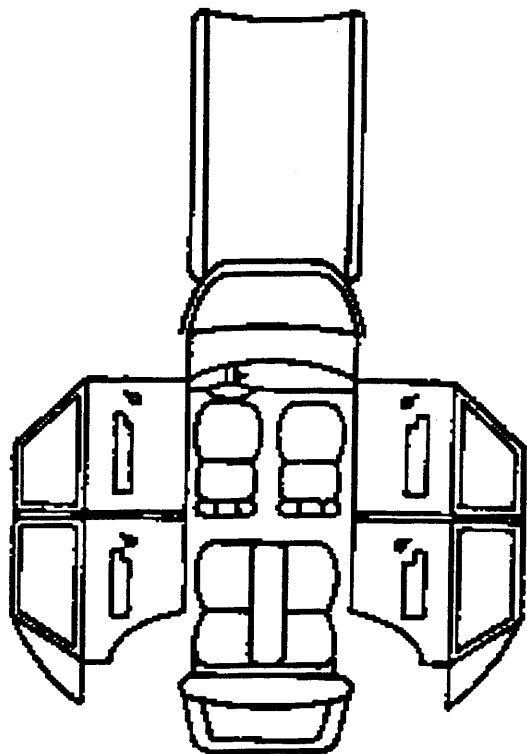
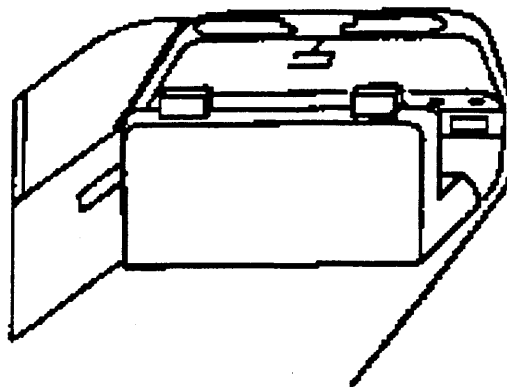
VEHICLE OCCUPANT CONTACT DIAGRAM

DR BELT: Adjusted Up
clothing transfers on lap-belt
webbing.
nothing on D-ring or latch
